Summary of Visual Dam Inspection: Lake Singletary Dam Millbury, Massachusetts

August 26, 2005

Town of Millbury Department of Public Works
127 Elm Street
Millbury, Massachusetts 01527

GZA GeoEnvironmental, inc.
One Edgewater Drive
Norwood, Massachusetts 02062
File No. 18604

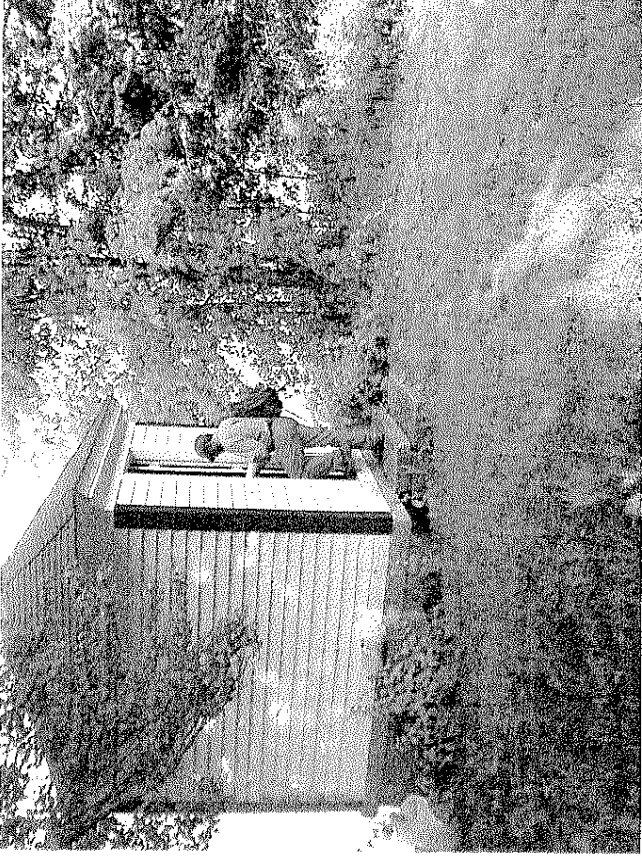
The upstream gatehouse structure appeared to be in good condition. The trash rack appeared to exhibit some rusting. The wooden gate itself was not visible. The gate is reportedly exercised regularly and in working condition, but should be inspected at the time of the next lake drawdown when it is visible. The gate houses are kept locked.

Description: Upstream gatehouse.

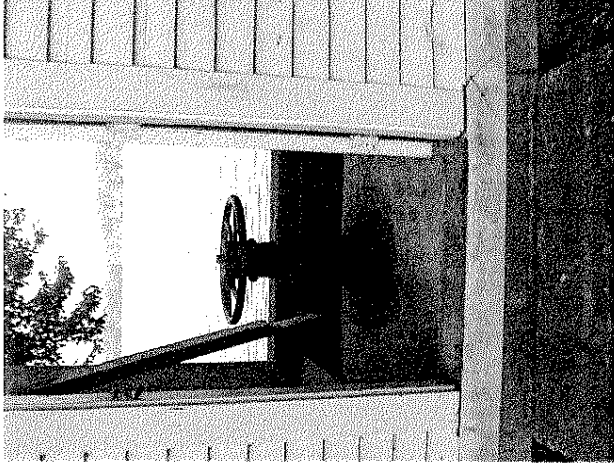
Description: Gate control at upstream gatehouse, with Lake Singletary in the background.

1. Conduct a detailed hydrologic and hydraulic investigation of the existing spillway and outlet structures and design and construct spillway repairs for additional spillway capacity, as required.
2. Establish a formal, written operations and maintenance plan.
3. Re-inspect gate and gate stem at upstream gatehouse when the lake is drawndown.

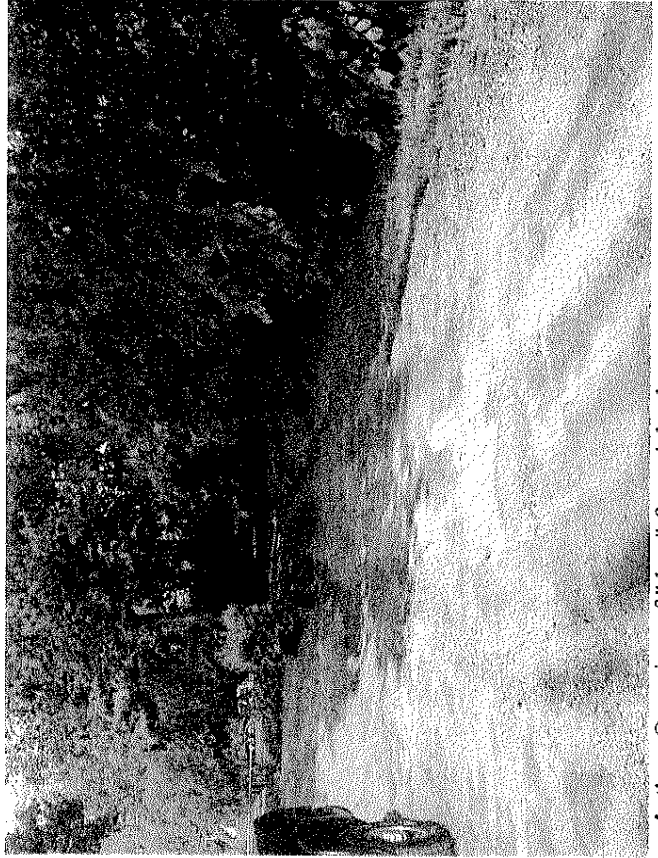
The embankment appeared to be in fair condition. Brush, trees, and poison ivy are located throughout the downstream portion of the embankment. The crest of the dam and gravel access roadway was uneven in places, and quite wide. Several homes are located on the dam crest. Previous inspection reports noted standing water at the downstream toe of the dam, which could not be verified due to the overgrown vegetation. Generally, the downstream area appeared to be dominated by wetland growth.

Description: Overview of "dam" from right abutment.

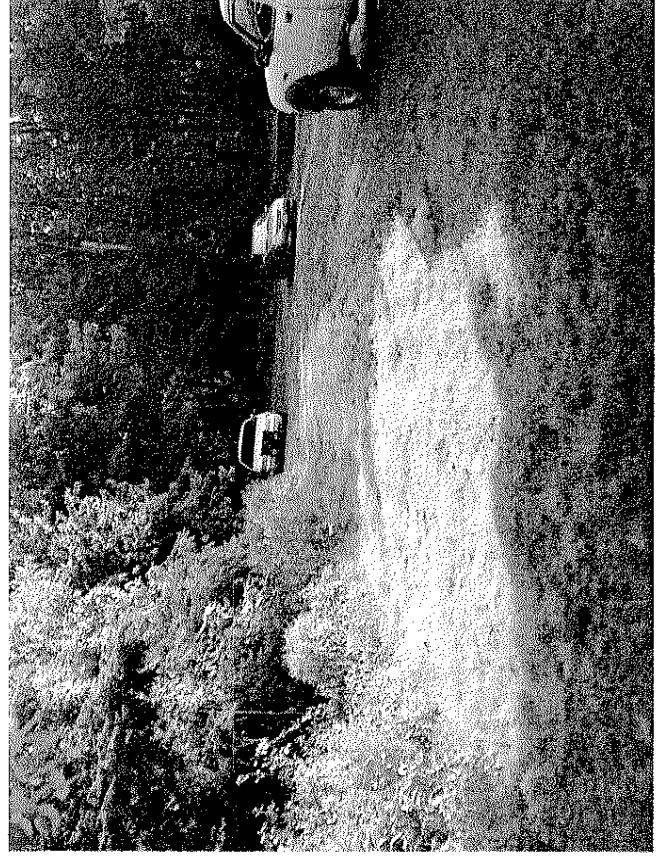
Description: Overview of "dam." from left abutment.

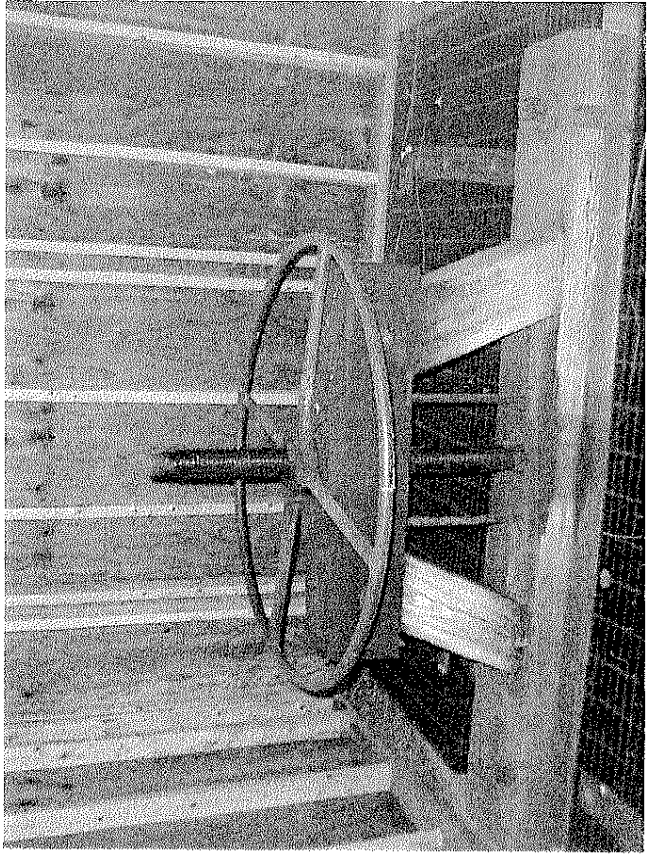
The immediate downstream gatehouse appeared to be in good condition. The downstream gate is no longer in use, as it had historically had problems with leakage. The concrete overflow and channel appeared to be in fair condition. The stone masonry at the channel was in fair condition—some minor repointing and clearing of vegetation is required.

Description: Gate control at downstream gatehouse (not used).

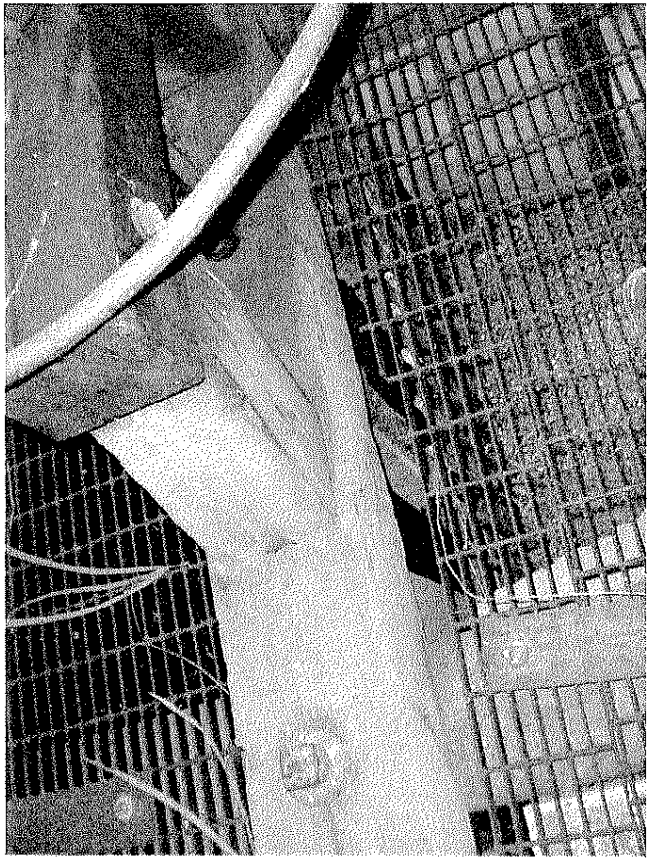
Description: Floor grate and weir at downstream gatehouse.

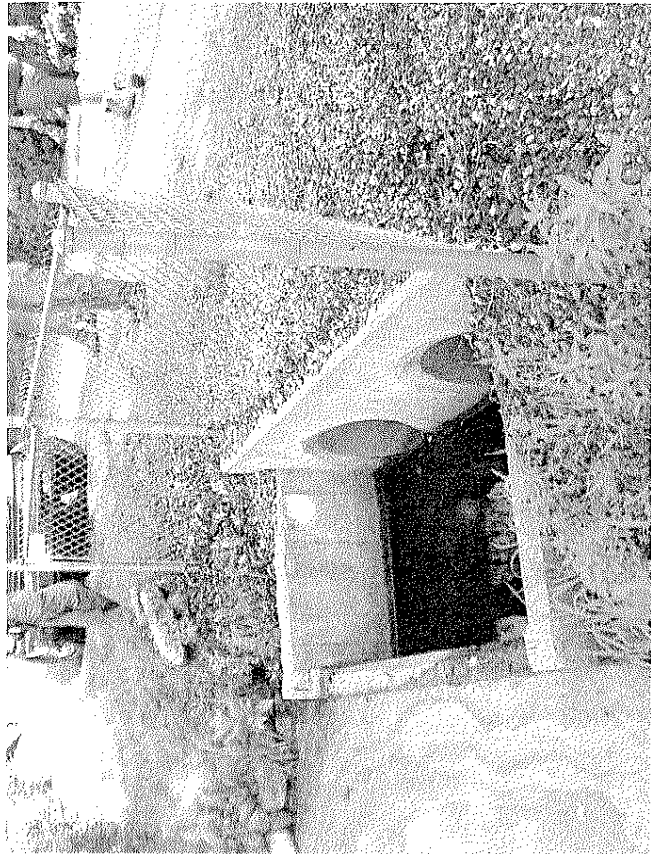
The emergency spillway appeared to be in good condition. The RCP culverts and utility box were in good condition. The downstream channel was overgrown with vegetation and should be cleared of debris.

Description: Emergency spillway culverts.

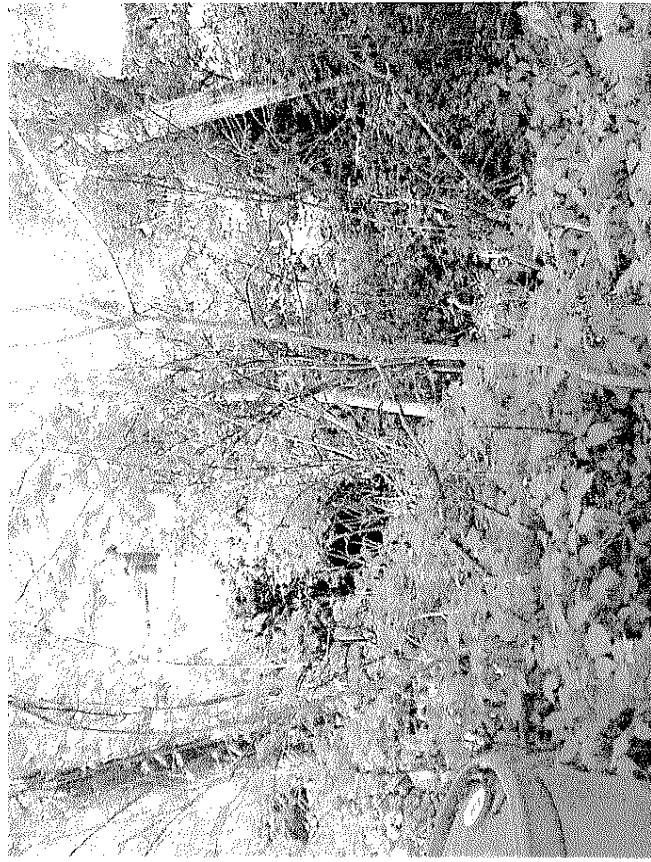
Description: Downstream channel for emergency spillway.

1. Remove brush, trees, and major root systems from downstream slope, and establish and maintain a grass cover.
2. Remove trees in downstream emergency spillway channel, debris, forest litter, and downed tree limbs, and establish riprap channel protection at pipe outlet.

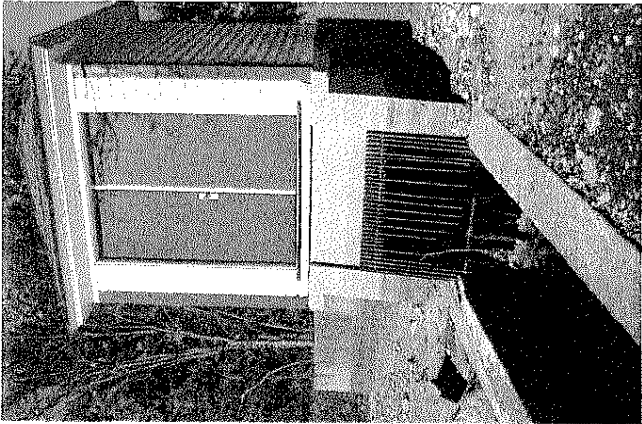
Description: From November, 2004: Inlet to upstream gatehouse.

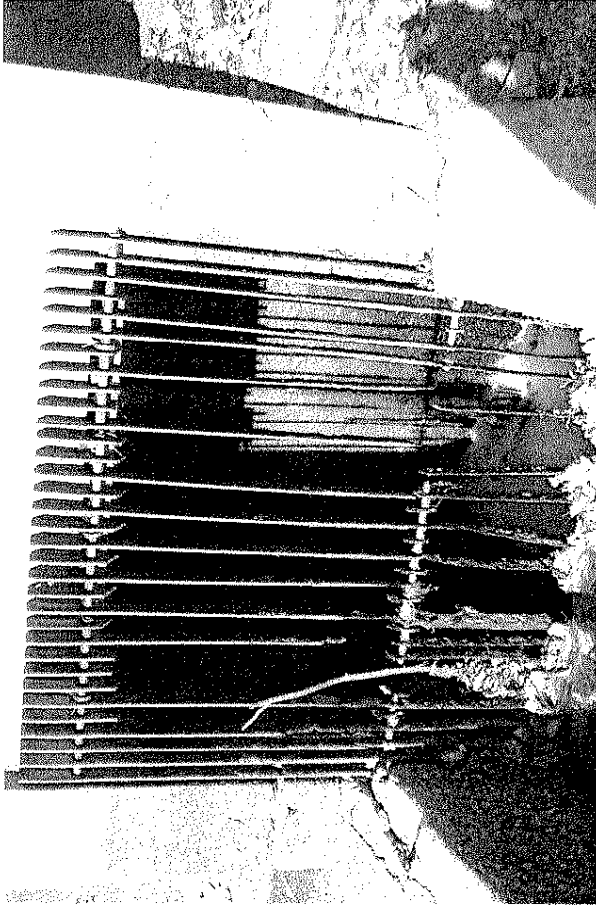
Description: From November, 2004: Upstream trash rack and inlet.

1. Repoint stone work in channel downstream of outlet gatehouse. Remove vines and other vegetation from channel walls.
2. Replace trash rack as planned. Continue to monitor the condition of the existing trash rack to determine schedule for repair or replacement.

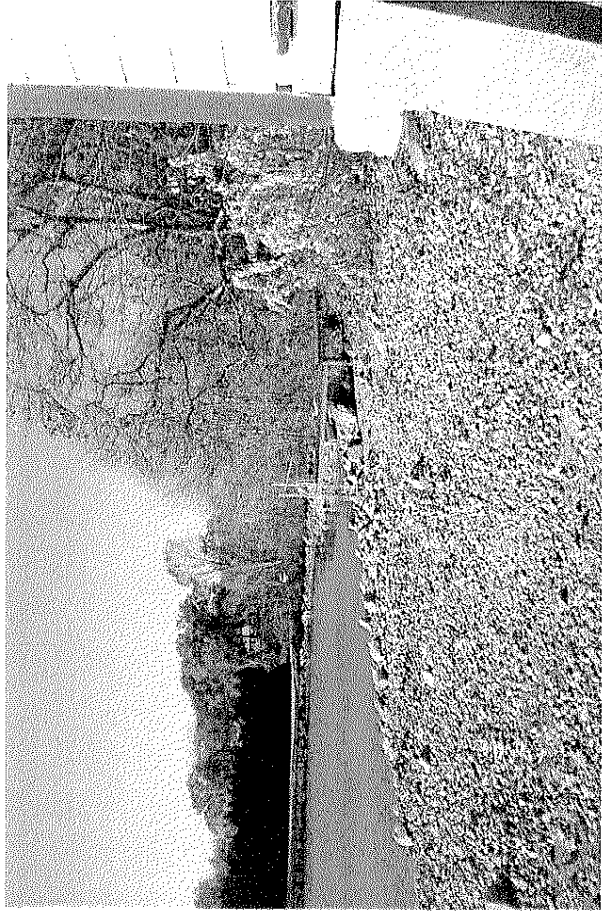
Description: From November, 2004: Drawdown lake from upstream gatehouse.

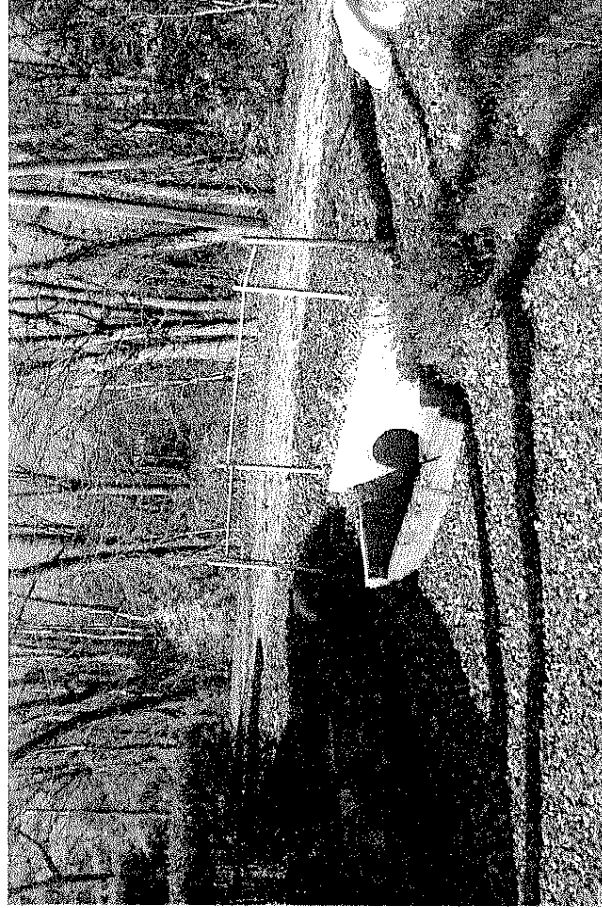
Description: From November, 2004: Emergency spillway structure.
